**CHEROKEE NATION
Environmental Programs**

Asbestos Sampling Report

SITE : 17798 S Muskogee Ave, Tahlequah, OK 74464

PREPARED BY: *Ashley Wagner* **DATE:** 12/1/2021
ASHLEY WAGNON, MANAGER

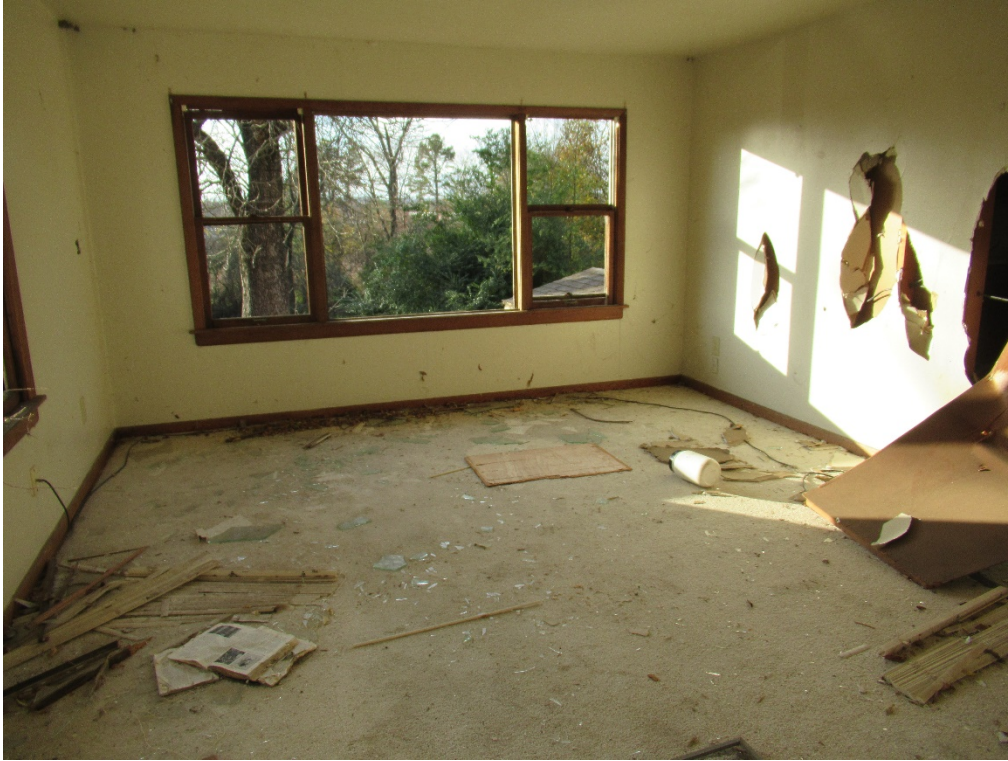
Sample #	Material Description	Locations	Friability (Friable, NF Cat I NF Cat II)	Condition	Sample Results (% Asbestos)
01-01 01-02 01-03 01-04 01-05 01-06 01-07	Wall & Ceiling Texture	Throughout	NF Cat II	Sig. damaged	3% Chrysotile
05-01	Red Siding	Exterior/Enclosed Porch	NF Cat II	Sig. damaged	20% Chrysotile
06-01	Gray 9x9 Floor Tiles	Lower Level	NF Cat I	Damaged	4% Chrysotile

Photograph 1: Wall and Ceiling Texture 3% Chrysotile Asbestos

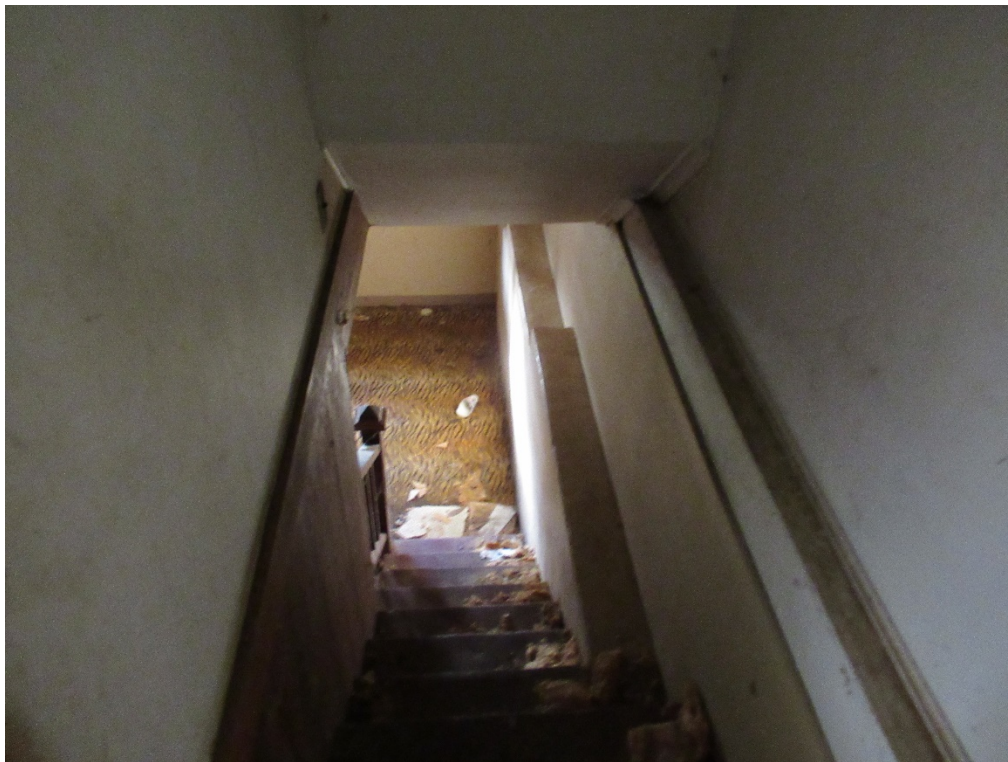
Photograph 2: 9x9 Floor Tiles below carpet on lower level, 4% Chrysotile Asbestos

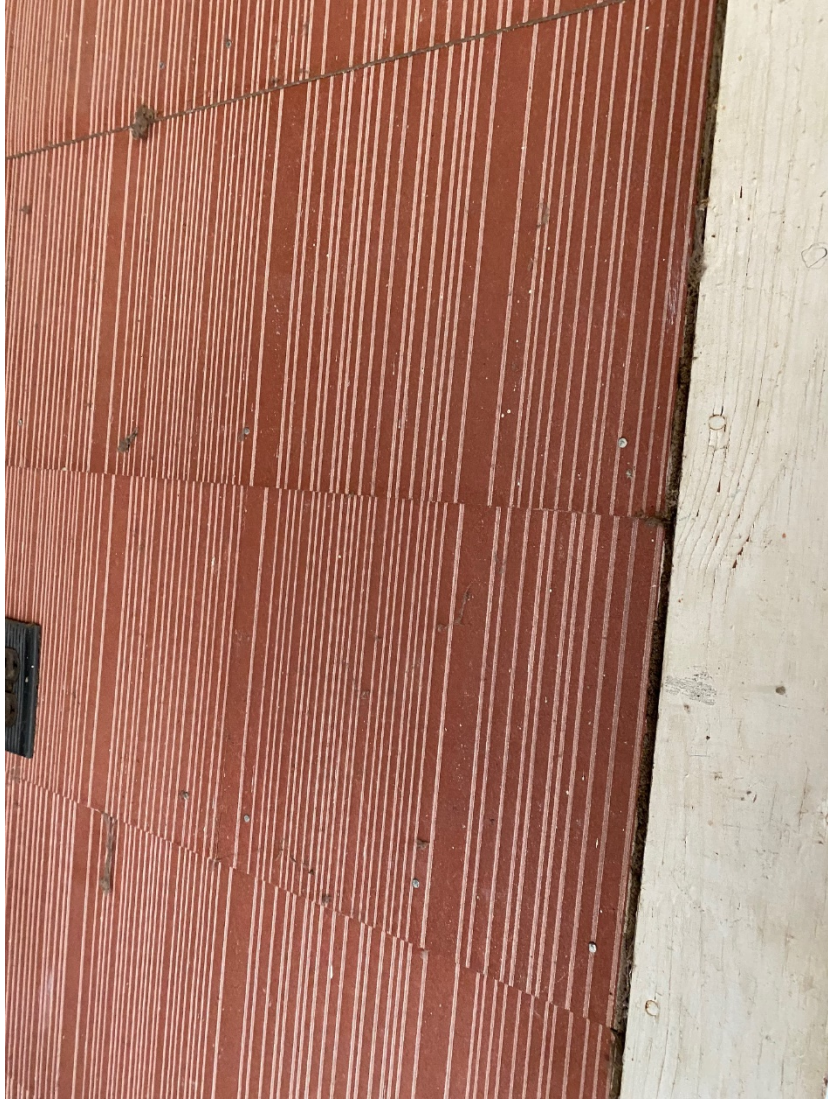
Photograph 3: Exterior Siding 20% Chrysotile Asbestos
