EXHIBIT A- DWIGHT MISSION ROOF REPLACEMENT

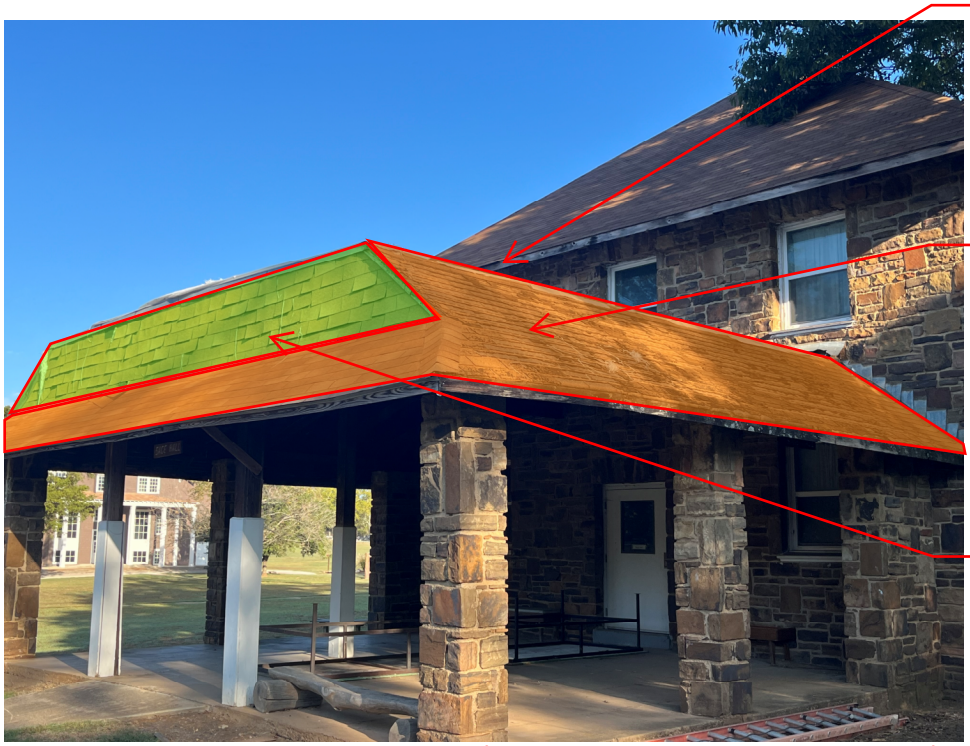
WALTON DINING HALL-NORTH DAMAGE

WALTON DINING HALL-SOUTH DAMAGE

DORM PORCHES (TYPICAL SAGE AND WASHBURN HALL)

EPDM ROOF (TOP, NOT SHOWN) ON FLAT ROOF. INCLUDE FLASHINGS AS REQUIRED AT ALL TRANSITIONS.

NEW ASPHALT SHINGLE ROOF OVER ADDED LAYER OF DECKING OVER REPAIRED DECKING. ADDED DECKING SHALL BE THICKNESS SUFFICIENT TO PREVENT ROOF NAILS FROM PROTRUDING UNDERSIDE.

HardieShingle STRAIGHT FAUX SIDING ON VERTICAL FACE. INCLUDE FLASHINGS AS REQUIRED AT TRANSITIONS.

UNDERSIDE OF DORM PORCHES, TYPICAL BOTH DORMS. REPAIR DECKING AS REQUIRED UNDER UNIT COST. ADD DECKING UNDER SHINGLE ROOF AREAS SUFFICIENT TO PREVENT ROOF NAILS FROM PROTRUDING UNDERSIDE. REPAIR DAMAGED STRUCTURAL MEMBERS.
